FINAL INSPECTION REPORT
United States Environmental Protection Agency (EPA) Region 4
Air Enforcement Branch

Facility Name: North Shelby Landfill, BFI Waste Systems of North America, Inc.

Inspection Dates: November 29-30, 2022

Type of Inspection (Full or Partial Compliance Evaluation):
Clean Air Act Partial Compliance Evaluation

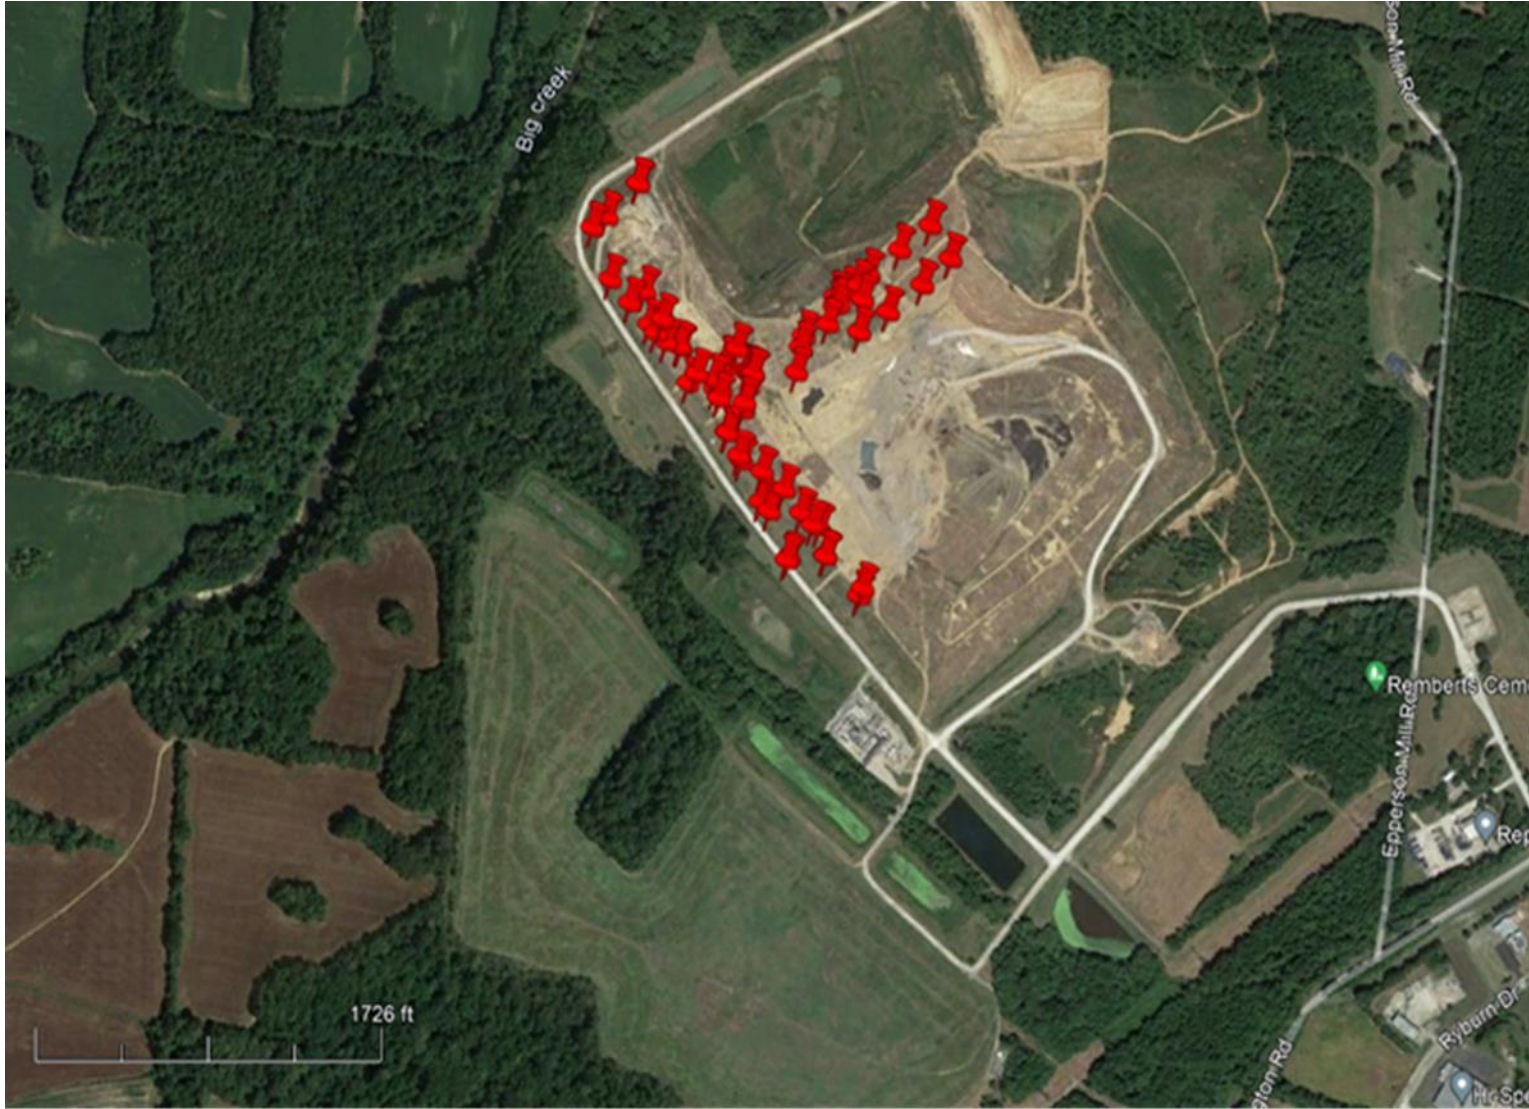
Methane was measured at 72 landfill cap penetrations over the two-day inspection (mostly gas collection wells, but other penetrations as well). Methane concentrations at 61 of the 72 penetrations monitored exceeded the 500-ppm threshold (Note: a gas collection well might have two or three other penetrations associated with it. Often more than one, or all the penetrations close to each gas collection

well were over the 500-ppm threshold. If this was the case, only one reading was recorded for the entire well cluster.) There were also six locations above 500 ppm that were not associated with penetrations.

Locations where surface emissions were determined to be >500 ppm during the inspection.
